XCF00S PROM Errata and Deviations from XCF00S Data Sheet

DS123-E02 (v1.1) May 26, 2004

Errata Notice

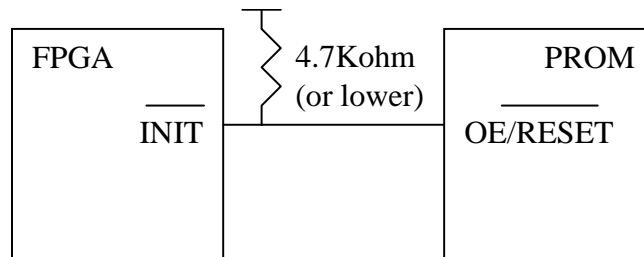
Figure 4: Recommended Resistor Value

- A slow ramp of the OE/RESET# (INIT#) signal. As specified in the data sheet, an external resistor of 4.7-Kohm (or lower) is required to quickly pull up the FPGA INIT and PROM OE/RESET# signal line. If the FPGA INIT and PROM OE/RESET# signal line rises too slowly, then system noise might corrupt the PROM's internal address counters, thus keeping the FPGA from configuring properly.

Follow the data sheet to ensure that an external 4.7 KΩ (or lower) resistor is connected to the PROM's OE/RESET# pin and the FPGA's INIT# pin. Ensure that the FPGA TICCK specification is met (500ns). This translates to a Trise and Tfall time of 500ns for the PROM's OE/RESET# signal.

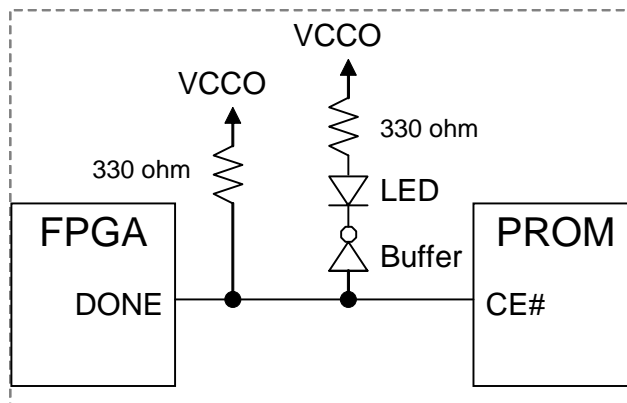
Figure 8: (LED with Buffer Circuit)

The FPGA has a sink current specification of 12 mA that is exceeded when an un-buffered LED is tied to the CE# (DONE) signal (Figure 5). In this scenario, the CE# (DONE) signal is held at an intermediate voltage level that mimics multiple input pulses (Figure 7). These pulses propagate through the PROM and cause the internal circuits to get out of sync. The observed failure rate is up to 50% of configuration cycles. Figure 6 shows a clean CE# (DONE) signal when it is not tied to an LED.

When using FPGA DONE to drive PROM CE# (to reduce standby power), make sure that the signal is within the specification and has a fast rise and fall time. Use an external buffer to drive any LED (Figure 8). If DONE is not used to drive CE#, it can be connected to an LED (Figure 9).

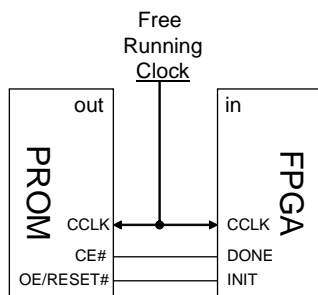
Figure 10: Asynchronous System

In most applications, the FPGA sources the CCLK signal, which synchronizes with the CE# (DONE) and OE/RESET# (INIT#) signals. However, in an asynchronous system (Figure 10), meaning when an external free-running clock drives the configuration clock signal (CCLK), then there is a probability that a missed or extra pulse(s) can be interpreted by the PROM's internal counters as CCLK transitions while the OE/RESET# (INIT#) signal is in its intermediate phase (Figure 11). The observed failure rate ranges from 0.1% to 1% of configuration cycles.

There is no application work-around that will avoid exposure to the phenomenon when a free running clock is used. Customers must design a system that does not utilize a free-running clock for configuration, such as utilizing the FPGA's internal clock to drive CCLK during configuration, or Master-Serial configuration mode.

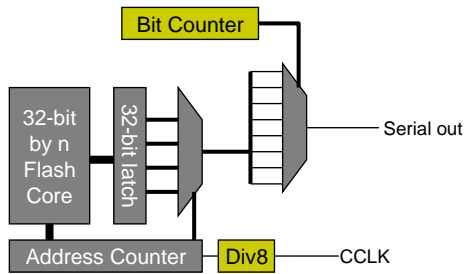
Figure 12: Counter Circuits

A Rotated Bit Pattern occurs when the Bit Counter and the Div8 circuit (Figure 12) becomes desynchronized. Data bits within a byte will be consistently rotated, byte by byte (Figure 13). Table 3 (above) summarizes the conditions where a Rotate Bit Pattern can occur.

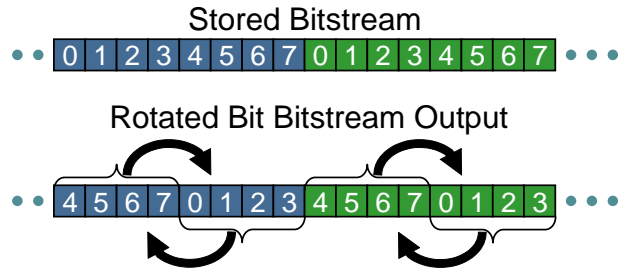
Figure 13: Example of Rotated Bit Pattern

Above diagram shows example of circuits being 4 bits out of sync

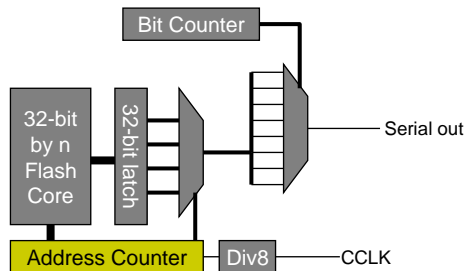
Figure 14: Counter Circuits

The Address Counter misses the first increment and repeats the first 32 bits. Table 3 (above) summarizes the conditions where an Extra 32 Bits pattern can occur.

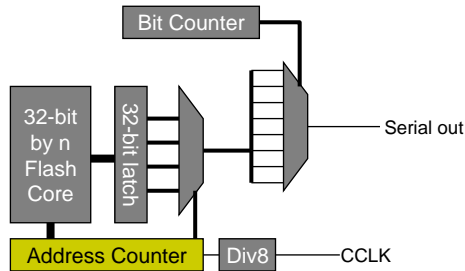
Figure 16: Counter Circuits

The Address Counter increments more than once and misses the second 32 bits. Table 3 (above) summarizes the conditions where a Missing 32 Bits pattern can occur.
