Introduction

Thank you for participating in the Spartan®-6 Engineering Sample Program. As part of this program, we are pleased to provide to you engineering samples of the devices listed in [Table 1](#). Although Xilinx has made every effort to ensure the highest possible quality, these devices are subject to the limitations described in the following errata.

Table 1: Devices Affected by These Errata

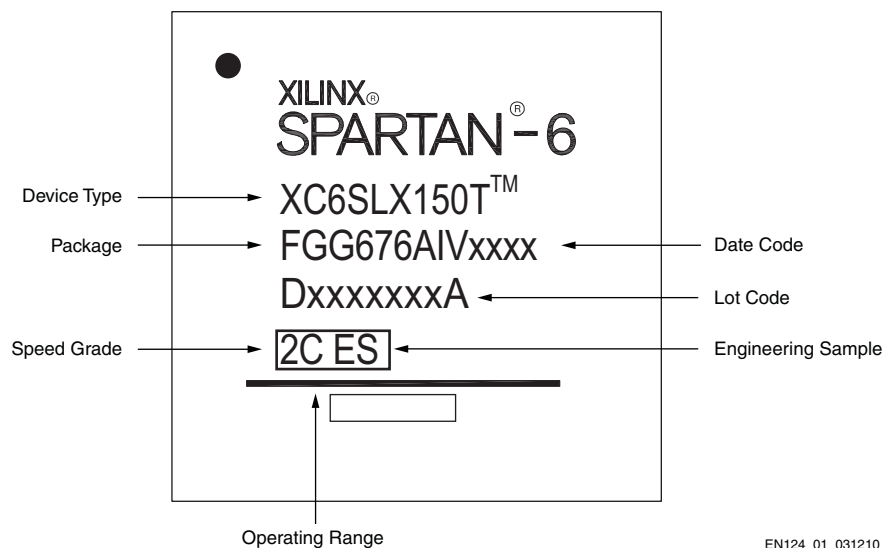
Figure 1: XC6SLX150T-2FGG676CES Marking

The XC6SLX150T is marked as shown in [Figure 1](#). The other devices listed in [Table 1](#) are similarly marked.
