Introduction

Thank you for participating in the Xilinx Virtex™-4 Engineering Sample Program. As part of this program, we are pleased to provide to you engineering samples of the Virtex-4 XC4VSX25 FPGA. Although Xilinx has made every effort to ensure the highest possible quality, these devices are subject to the limitations described in the following errata.

Table 1: XC4VSX25 FPGA Devices Affected by These Errata

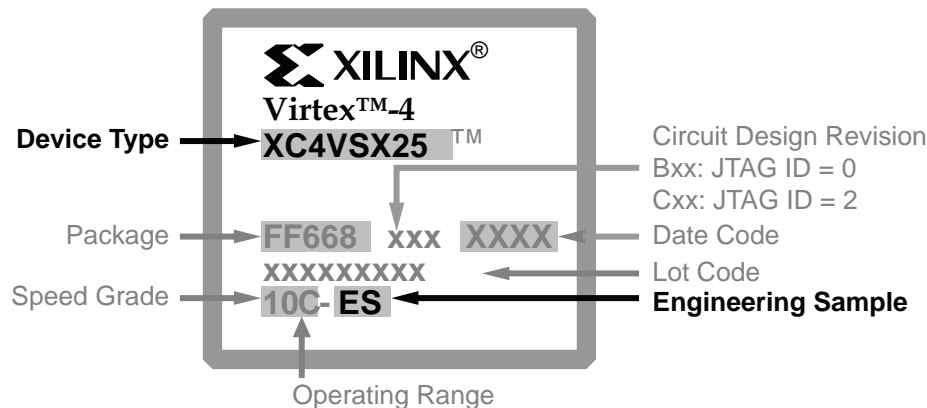
Figure 1: Example XC4VSX25CES Package Marking

The XC4VSX25 is marked as shown in Figure 1.
