Introduction

Thank you for designing with the Xilinx Virtex®-6 family of devices. Although Xilinx has made every effort to ensure the highest possible quality, the devices listed in [Table 1](#) are subject to the limitations described in the following errata.

Hardware Errata Details

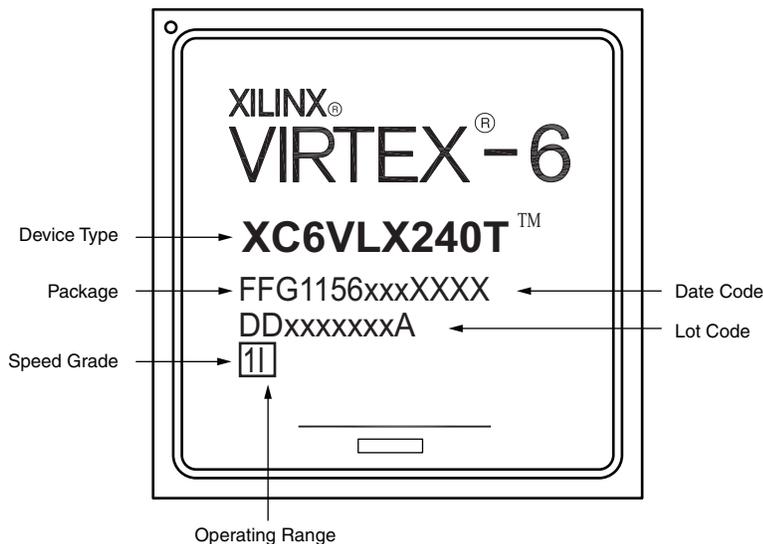
Figure 1: XC6VLX240T-1FFG1156I Marking

The XC6VLX240T is marked as shown in [Figure 1](#). The other devices listed in [Table 1](#) are marked similarly.

Date	Version	Description
03/26/10	1.0	Initial Xilinx release.
04/09/10	1.1	Updated Figure 1 .
05/07/10	1.2	Added Commercial devices. Updated Hardware Errata Details section. Added Dual Port Block RAM Address Overlap in READ_FIRST and Simple Dual Port Mode and GTX Transceiver Initialization for Proper TXOUTCLK Functionality sections. Updated Operating Range , noting applicability for Industrial grade devices only.
06/04/10	1.3	Added LX195T production device. Updated Dual Port Block RAM Address Overlap in READ_FIRST and Simple Dual Port Mode . Updated Operating Range . Updated Design Software Requirements .
06/18/10	1.4	Added the LX75T device and updated JTAG IDs and speed grades in Table 1 . Added System Monitor.
07/02/10	1.5	Added LX760, LX550T, SX475T, and SX315T production devices. The LX760 device does not include transceivers so the GTX Transceivers (Does not apply to the LX760 Device) section does not apply to it.
