## Introduction

Thank you for designing with the Zynq® UltraScale+™ MPSoC family. Although Xilinx has made every effort to ensure the highest possible quality, the devices listed in [Table 1](#) are subject to the limitations described in the following errata.

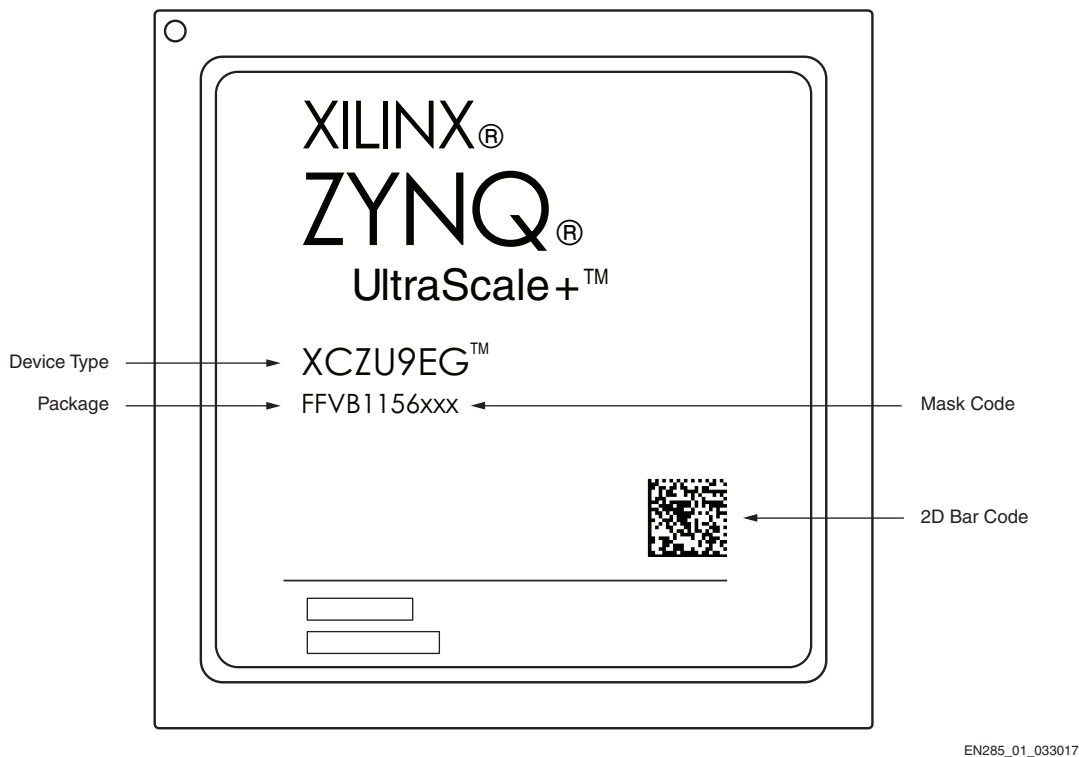
Figure 1: Example Device Top Mark

Figure 1 shows an example device top mark for the devices listed in Table 1.
