Introduction

Thank you for designing with the Zynq® UltraScale+™ MPSoC family. Although Xilinx has made every effort to ensure the highest possible quality, the devices listed in [Table 1](#) are subject to the limitations described in the following errata.

Table 1: Devices Affected by These Errata

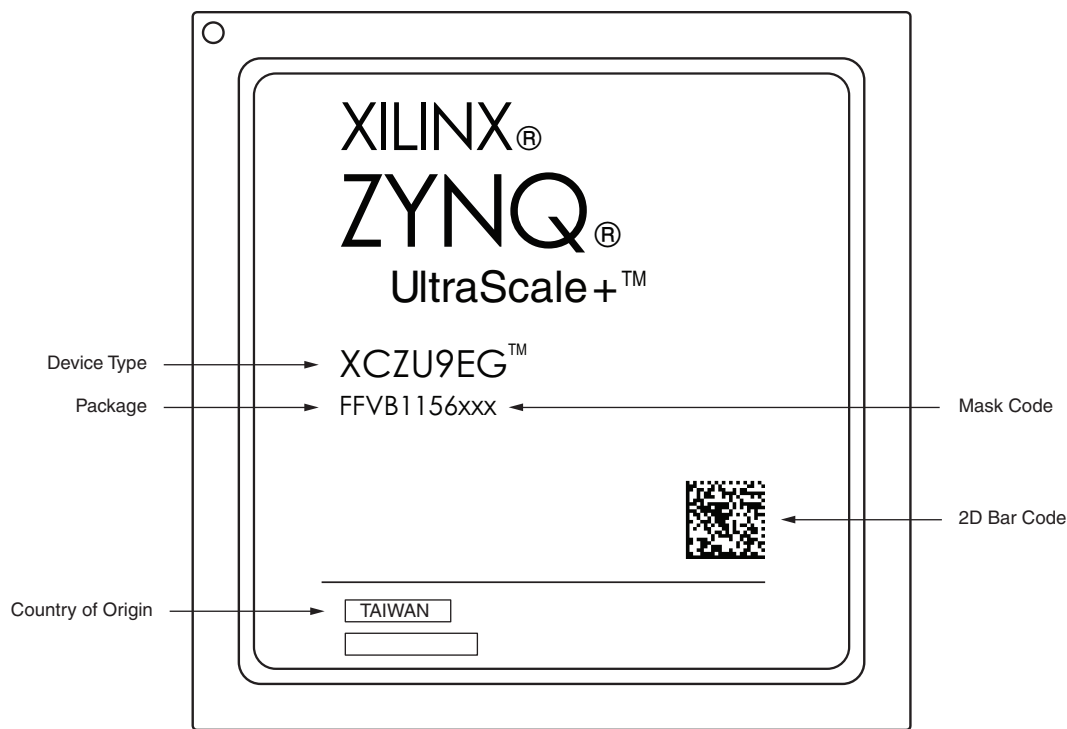
Figure 1: Example Device Top Mark

Figure 1 shows an example device top mark for the devices listed in Table 1. Note that the XQ Zynq UltraScale+ device top mark includes only the Xilinx logo, 2D bar code, and country of origin.

Date	Version	Description of Revisions
10/30/2018	1.8	Added XQ Zynq UltraScale+ MPSoCs. Updated Figure 1 .
08/20/2018	1.7	Added PS DNA Is Not Write Protected And Is Different Than PL DNA .
07/23/2018	1.6	Updated with XAZU4EV and XAZU5EV devices.
04/17/2018	1.5	Added LPDDR3/LPDDR4 Temperature Derating Does Not Work When Initial DRAM Temperature Is Greater Than 85°C .
12/06/2017	1.4	Table 1 : Added XCZU4EV, XCZU5EV, and XCZU7EV. Added Programmable Logic (PL) Errata Detailed Descriptions and Table 3 for new errata: Decoding An HEVC Video Bitstream With Level 4 Or 4.1 With Greater Than 4K Pixels Per Line Results In Corruption In The Decoded Picture ; Decoding An HEVC Video Bitstream With 8K Pixels Per Line With Sample Adaptive Offset (SAO) Filter Enabled Results In Corruption In The Decoded Picture ; and Decoding An 8K CAVLC Video Bitstream Might Hang .
10/05/2017	1.3	Table 1 : Added XCZU11EG, XAZU2EG, and XAZU3EG; updated JTAG ID Code column header to IDCODE[31:0]; and added table note. Added PS DDR Inputs Do Not Switch To Boundary-Scan Compatible Mode .
