Introduction

Thank you for designing with the Zynq® UltraScale+™ MPSoC family. Although Xilinx has made every effort to ensure the highest possible quality, the devices listed in [Table 1](#) are subject to the limitations described in the following errata.

Table 1: Devices Affected by These Errata

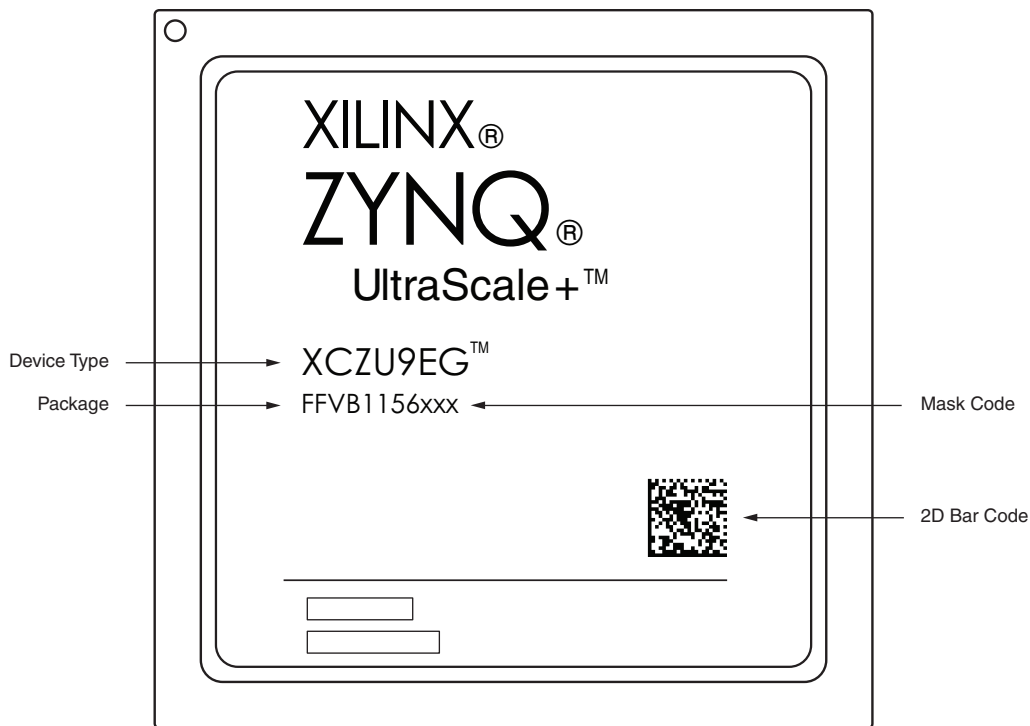
EN285_01_033017

Figure 1: Example Device Top Mark

[Figure 1](#) shows an example device top mark for the devices listed in [Table 1](#).
