## Introduction

Thank you for designing with the Zynq® UltraScale+™ RFSoc family. Although Xilinx has made every effort to ensure the highest possible quality, the devices listed in [Table 1](#) are subject to the limitations described in the following errata.

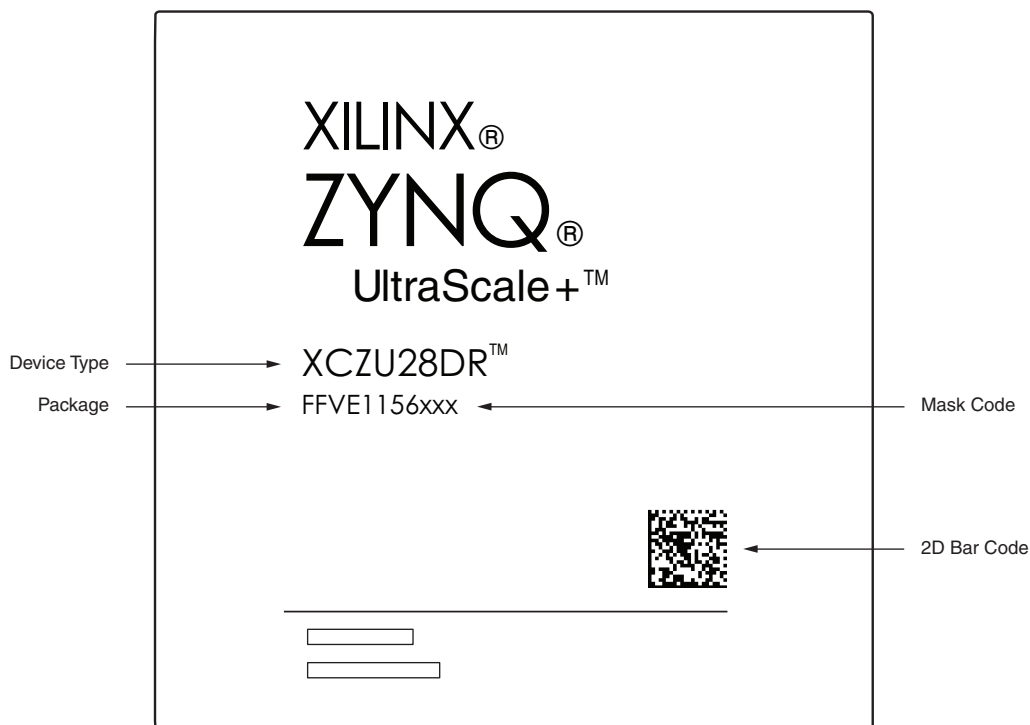
Figure 1: Example Device Top Mark

Figure 1 shows an example device top mark for the devices listed in [Table 1](#).
